BMW Engine Breather Assembly Issue

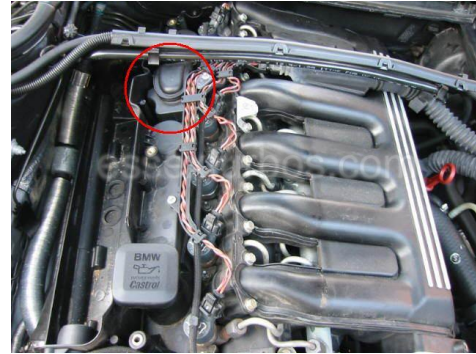
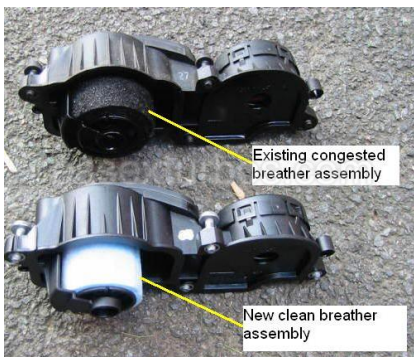
One of the most common reasons for this is the breather assembly on top of the rocker cover is not changed regularly enough so gets congested/ blocked and causes the engine to breathe heavily.

This causes increased crank case pressure which creates an increase in pressure in the sump pushing the oil back up the oil return pipe. This effectively blocks the oil return pipe so the oil entering the turbo through the oil feed pipe cannot escape out the oil drain pipe. As it backs up it is forced out the turbo sideways past the piston rings (seals) into both the turbine housing (exhaust housing) and compressor housing (Air intake housing).
